Name Of Dam: TOWNES DAM

Inventory Number: VA 14102

PHASE I INSPECTION REPORT NATIONAL DAM SAFETY PROGRAM

SEPTEMBER 1978

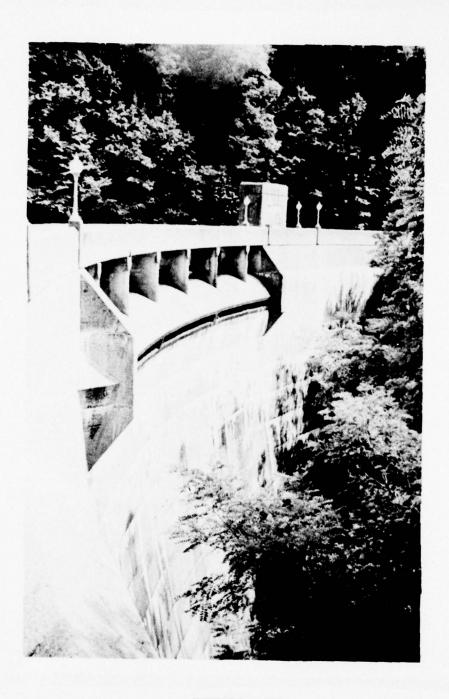
РНОТО 1

TOWNES DAM
NOTE LEACHING OF CALCIUM THROUGH CONSTRUCTION JOINTS

- 2.1 Seepage: Seepage was noted at the junction of the dam and the left wingwall of the stilling basin. The seepage had left a red stain. Leeching of calcium from the concrete has stained the dam face white at many construction and monolith joints, however, most of these joints did not appear to be seeping at the time of inspection. (This was difficult to determine since rain began at the start of the inspection.)

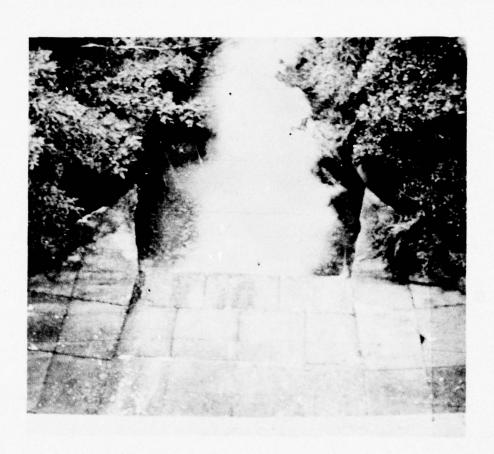
РНОТО 2

TOWNES DAM---VIEW OF STILLING BASIN TAKEN FROM TOP OF DAM

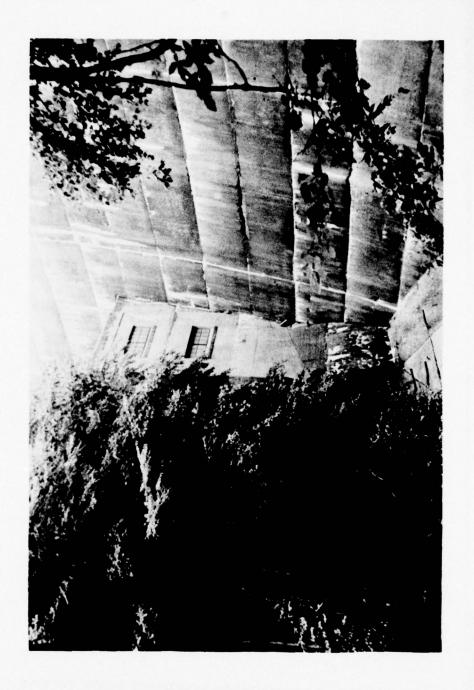
TOWNES DAM---OUTLET WORKS
TAKEN FROM LEFT WINGWALL OF STILLING BASIN

- 2.10 Construction Joints: Concrete formwork on the downstream face of the dam was poorly aligned with adjacent concrete. Cement mortar was placed over the construction joints (See Photo 3) probably to smooth the appearance of the dam. It is possible that the mortar "patchwork" was an attempt to stop seepage through the dam which can be seen in early photos. Most of these "patches" have spalled off of the dam. Calcium deposits are built up at construction joints from seepage through the joints.

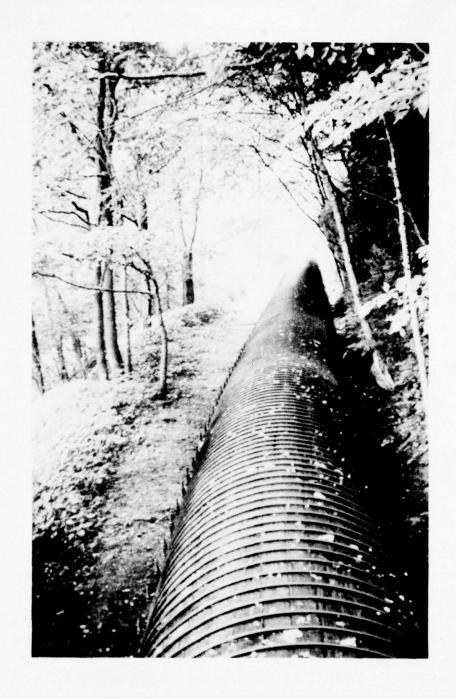
IUWMES DAM---72 INCH WOOD STAVE
PIPELINE TAKEN AT THE OUTLET WORKS
LOOKING DOWNSTREAM
PHOTO 4

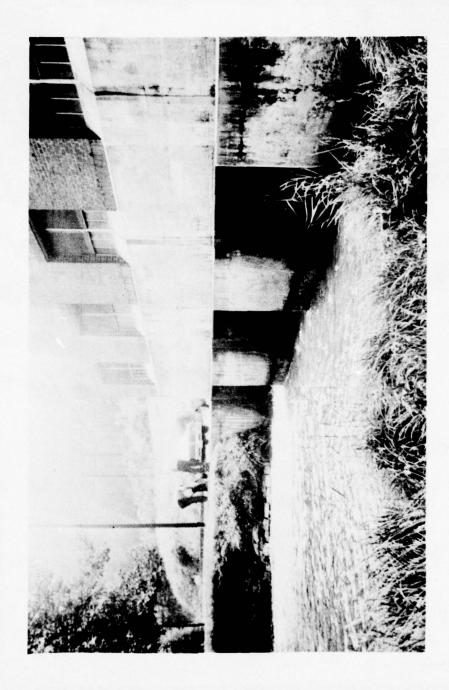
TOWNES DAM/PINNACLES HYDRO ELECTRIC POWER PLANT---VIEWS OF DISCHARGE OUTLETS FOR TURBINE GENERATORS

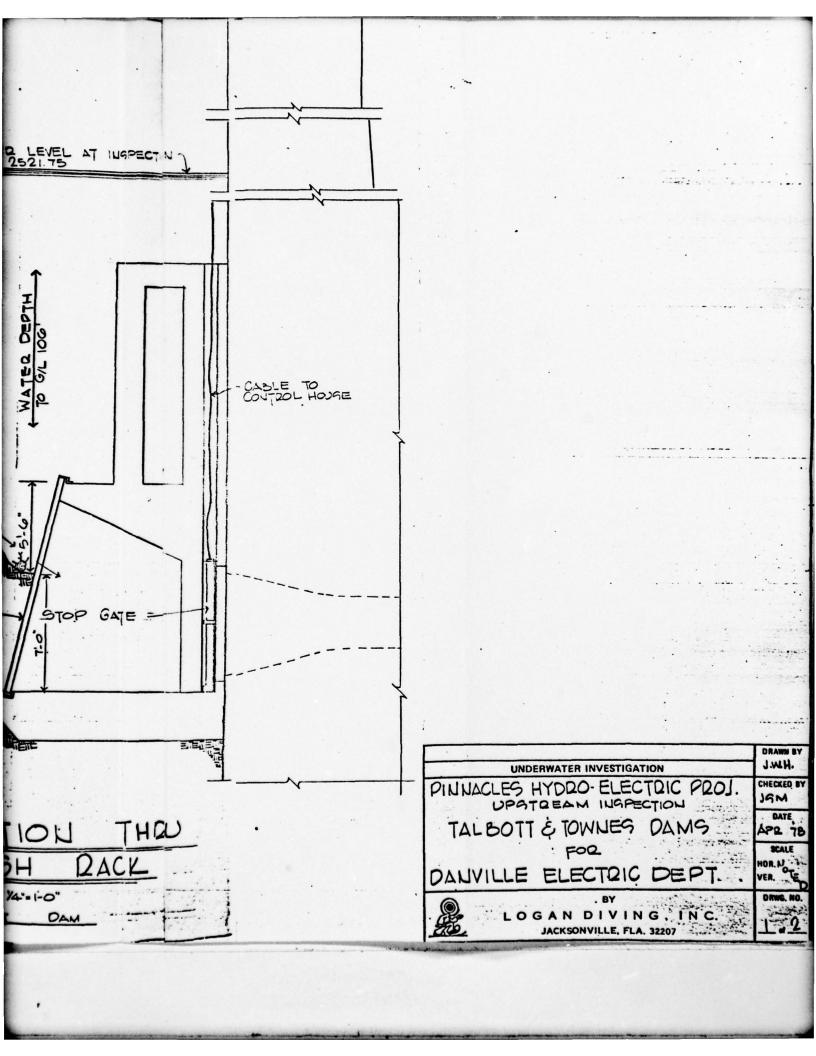
SECTION THOU TRASH RACK

WATER LEVEL AT INSPECTION ELEV. 2208.5 DAM WALL (TOWLES) TRASH RACK GUIDE-RUST BLISTERS TOP NEW HOOK & BLOCK PLACED ON DACK LIFTING EYE 1978 & PIPELINE -TRASH RACK-SECTION THOU

- 7.2.5 Trash Rack: It is recommended as outlined in the Logan Diving, Inc. report, that the city perform a semi-annual operational inspection of the trash rack and its motorized hoist, the motorized 70-inch butterfly valve, and the 12-inch gate valve. The inspection should be performed in the presence of the superintendent of the Pinnacles Hydro Station.
